# **Assessment of Hazards Resulting from the July 11, 2005 Landslide, Barangay Mayana, Jagna, Bohol**

A report to the Local Government Unit of Jagna, Bohol

**August 2005**

**National Institute of Geological Sciences  
University of the Philippines, Diliman, Quezon City**

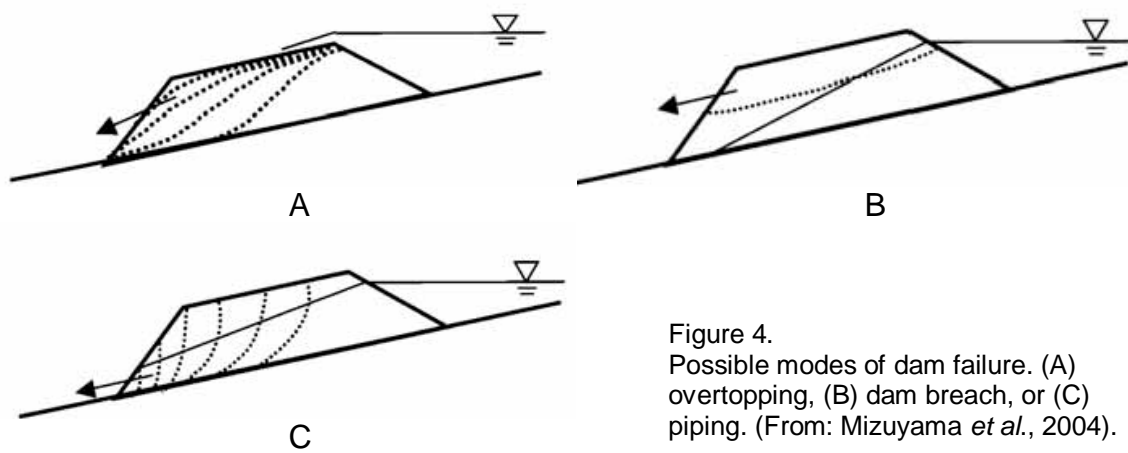
The preceding discussion focuses on possible mitigation measures related to failure of the dam by dam breach or overtopping. A more difficult problem is to determine the possibility of a dam failure induced by piping, in which water from the lake percolates through the dam, causes caving and the formation of conduits in the dam through which the lake water can drain. As the depth of the reservoir increases, the potential for piping increases because the impounded water exerts increasing pressure on the dam. Thus as the reservoir fills, the dam should be checked regularly for evidence of significant seepage. If seepage develops, then it should be routinely monitored for changes in the rate of seeping water, which could be evidence of increasing piping and decreasing stability of the dam.
